## PROPERTY INSPECTION REPORT

\_\_\_\_\_, **Cypress Texas in the community of Bridgeland**  
(Address or Other Identification of Inspected Property)

**Michael Cothran, C.I.O., TREI 2995**  
(Name and License Number of Inspector)

**03/19/2015**

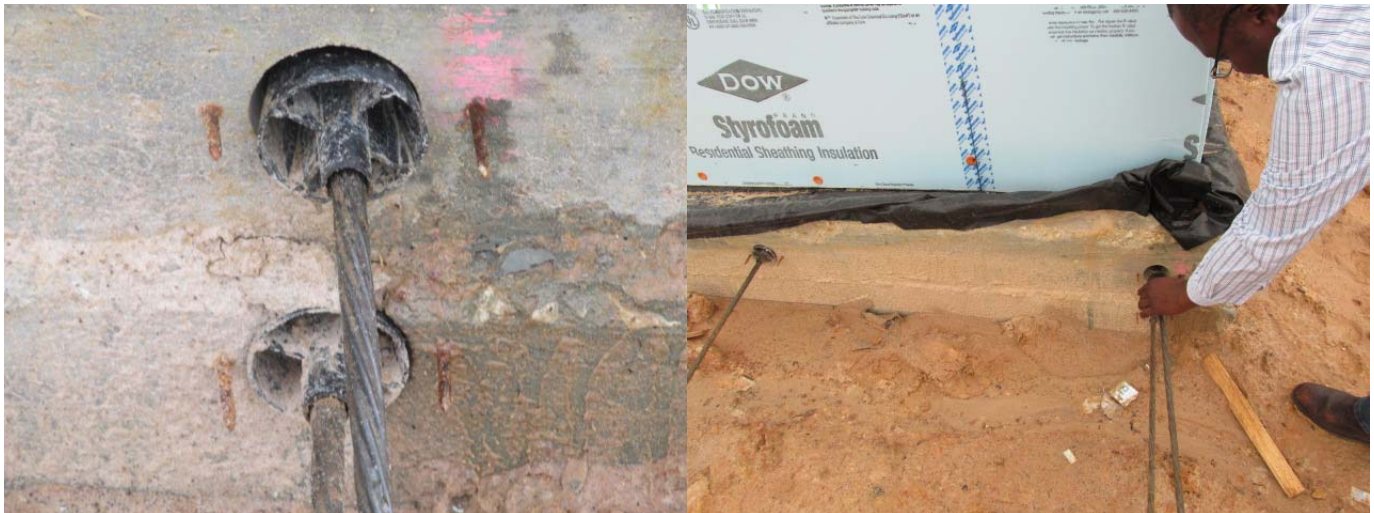
R – The foundation has not been tensioned at this time yet has frame, cornice and shingle loading on it. The lack of tensioning indicates that the foundation has not yet achieved structural integrity. No further loading should be placed on the foundation under tensioning has been achieved.

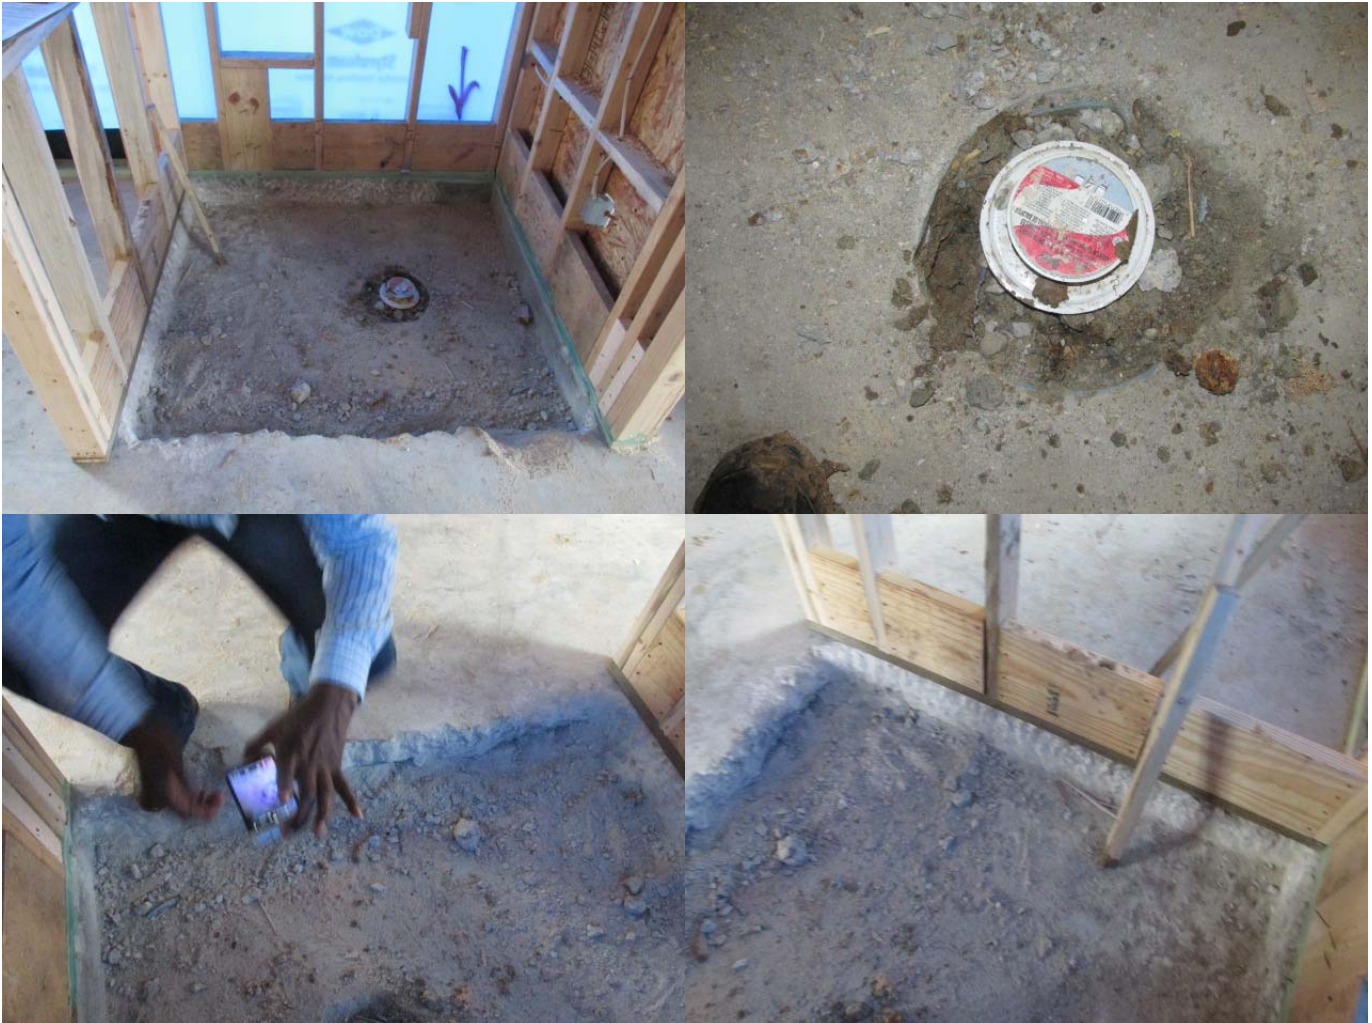
R – Three edges of the master shower have been broken out. The foundation is a monolithic foundation. Repairs which call for foundation breakout also require design engineer to plan, monitor and approve the repairs. The design engineer should deliver a letter to the client indicating the adequacy of this repair since nothing can be seen at this time. Items are;

1. Whether cables were bent, skinned or broken
2. Whether the moisture barrier has been breeched and repaired
3. The edges are not square and a concrete patch will not bond to the existing concrete

R – The shower drain has also been broken out;

1. The above applies
2. Moisture (ground water) is seeping around the drain, so the moisture has been breeched

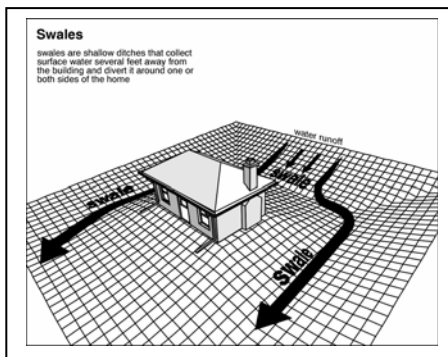
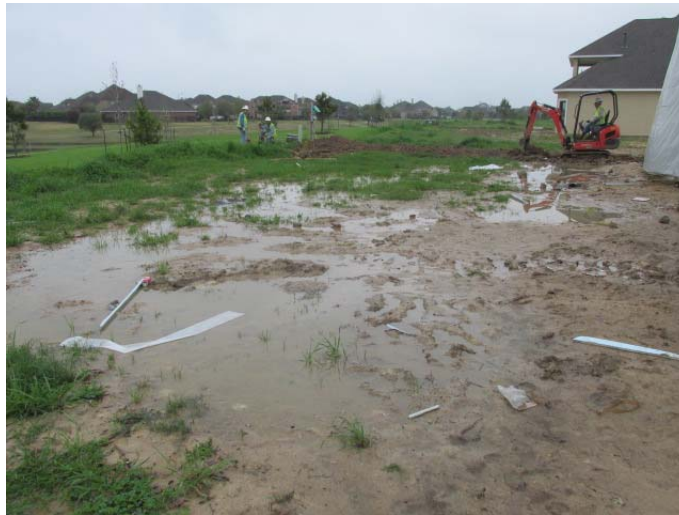
The grading for this lot appears to be rear to front. The plot plan was not present for confirmation.

R - The grading should be improved to promote the flow of storm water away from the house and off the lot. The ground should slope away from the house at a rate of one inch per foot for at least the first ten feet. Ideally, at least eight (8) inches of clearance should be maintained between soil level and the top of the foundation walls. See comments/recommendations under foundations. Trenching, against the foundation, is not acceptable. The target for slab exposure is 6 inches in sided areas and 4 inches in bricked veneer areas.

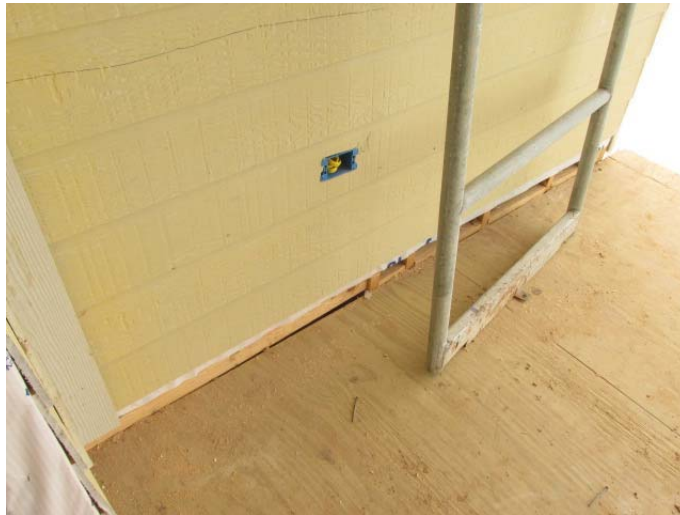
R – Flashing should be installed around the balcony.

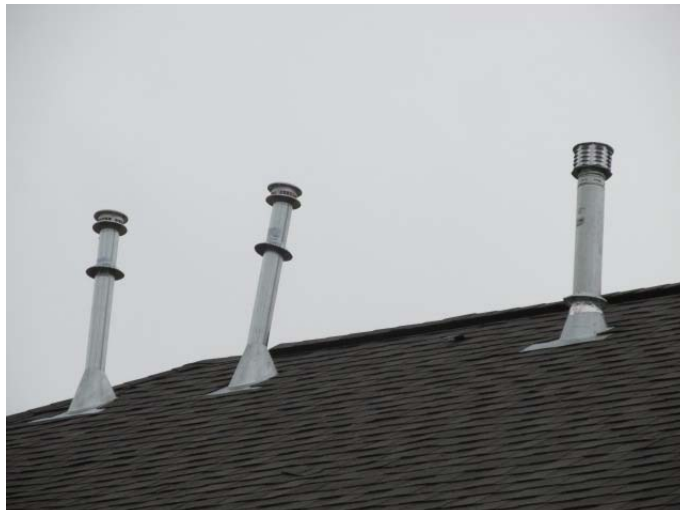
R - Both water heater flue storm collars are installed high and allow water entry.

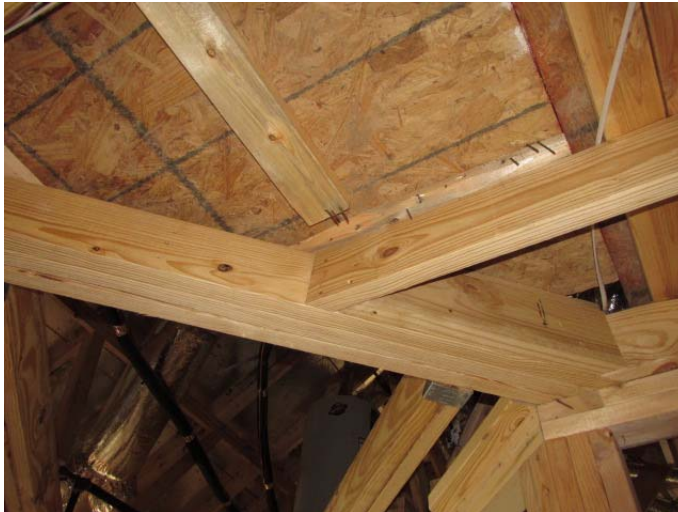
R – Missing joist hangers;

One angled joist near the attic stairs.

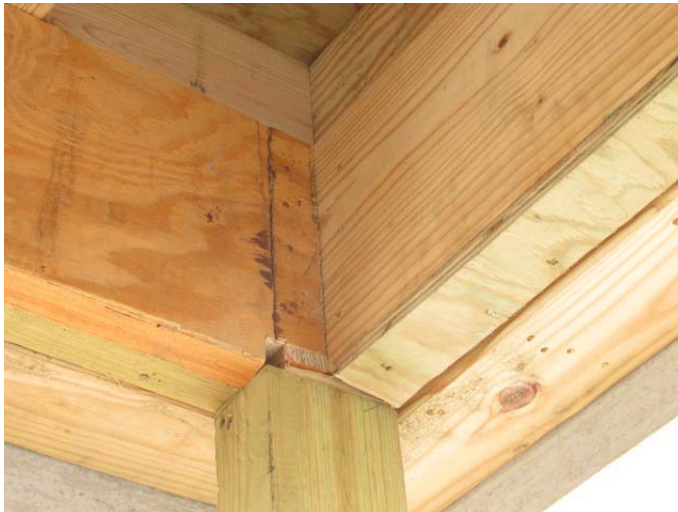
R – The engineered beam ending on the patio post is notched, this is not permitted without approval from the manufacturer.

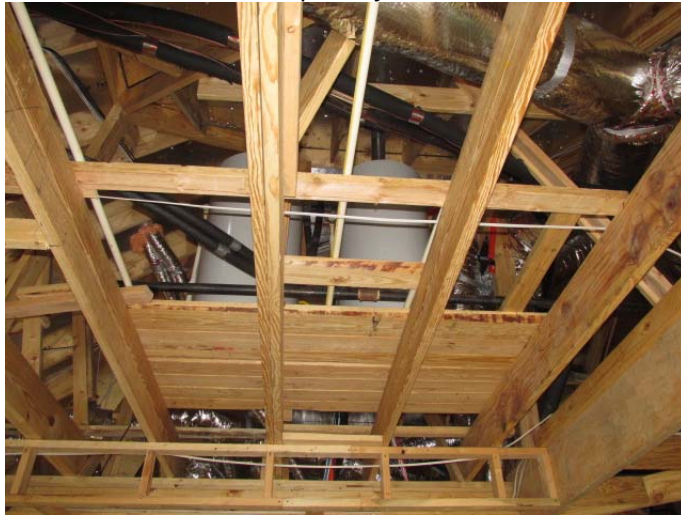
R – The water heaters are installed above the game room where the 2x10 joists are installed and spaced 24" on center. The joists are sized to span the room but not carry approximately 1000 lbs of full water heaters and provide a continuous load path\*\*\*. They would have been better been above the bath and hall walls just to the front of their present location.

**Continuous Load Path will be discussed in relation to several issues in this home, the Code requirement can be found at...Load path requirements IRC 301.1. Actually the need for CLP is common sense. It is simply and adequate path to convey loading or weight from the areas above the foundation, down to the foundation.**

Load path requirements are found in the IRC 301.1 code reference. IRC is the law of the land adopted by Texas in 2001.

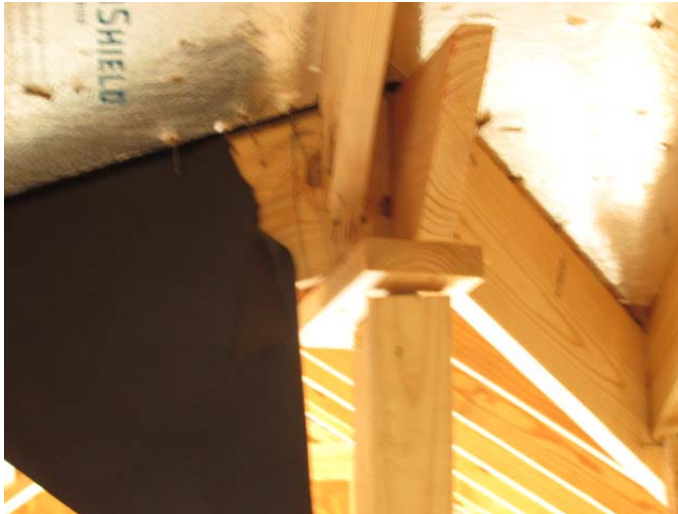
R - Ridge board supports were observed with palm blocking (a local terminology) at tops of the vertical supports. There is no reference to palm blocking or brace in any section or Wood Frame Construction Manual under IRC R301.2.1.1 Design criteria. Palm braces appeared with production framing sub-contractors as a basic short cut and not seen in older properties. With palm braces there does not appear to be a direct connection between the brace and what it is supporting and not subject to nail withdraw and tension/lateral load. We did not observe a metal hold-down strap from the ridge board and down across the to the vertical ridge brace to exacerbate a continuous fastening or hold-down path. As such the bottom of the vertical brace should be with a hold-down strap as well to complete the continuous load path and mitigate lateral or tension loads.

**IRC 802.3 Framing Details** – “Rafters shall be framed to ridge board or to each other with a gusset plate as a tie. Ridge board shall be at least 1-inch (25mm) nominal thickness and not less in depth than the cut end of the rafter. At all valleys and hips there shall be a valley or hip rafter not less than 2-inch (51mm) nominal thickness and not less in depth than the cut end of the rafter. **Hip and valley rafters shall be supported at the ridge by a brace to a bearing partition or be designed to carry and distribute the specific load at that point.** Where the roof pitch is less than three units vertical in 12 units horizontal (25% slope), structural members that support rafters and ceiling joists, such as ridge beams, hips and valleys, shall be designed as beams.”

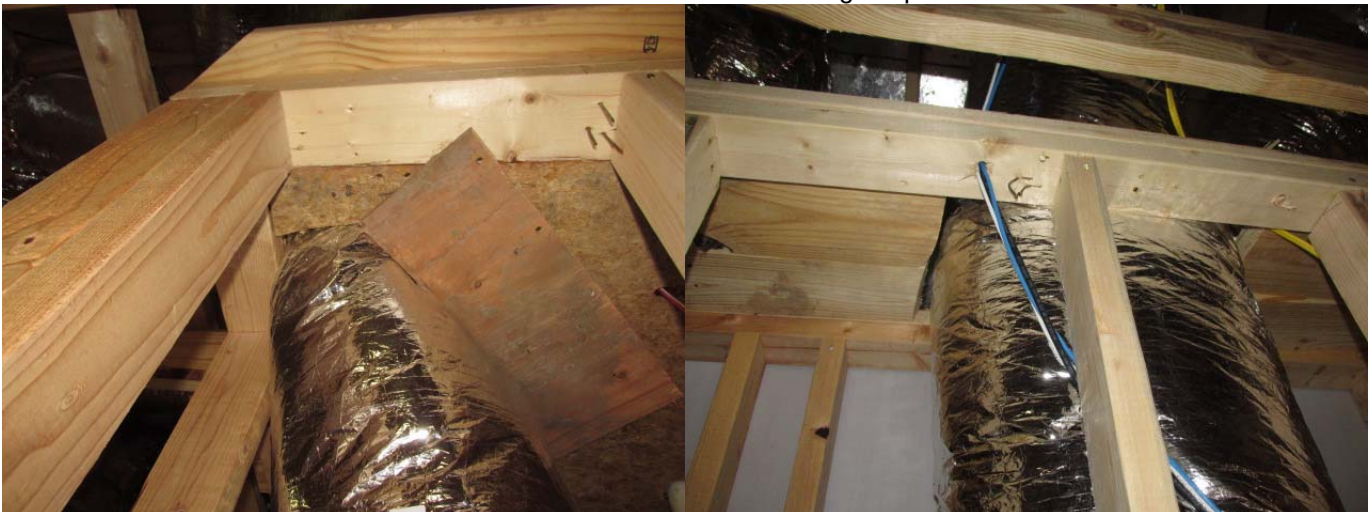
R – Air conditioning chases, which carry the ductwork from the attic to the floors of the home, must be fireblocked between floors and at the attic floor.

IRC R 602.8 Fireblocking Required

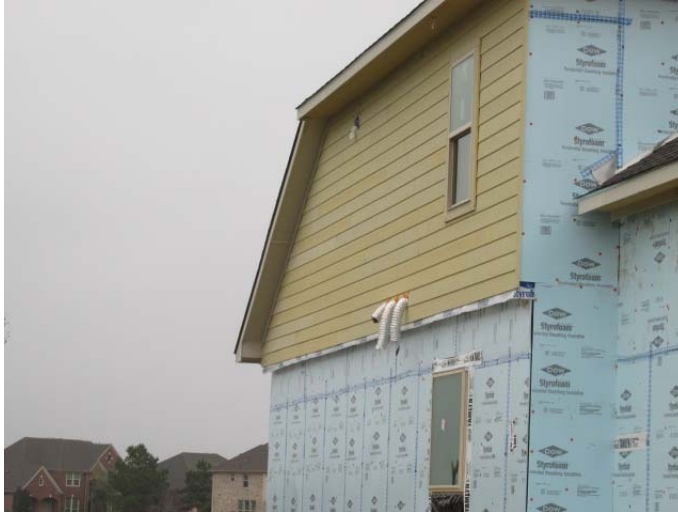
R – Install wall vent caps prior to drywall and insulation.

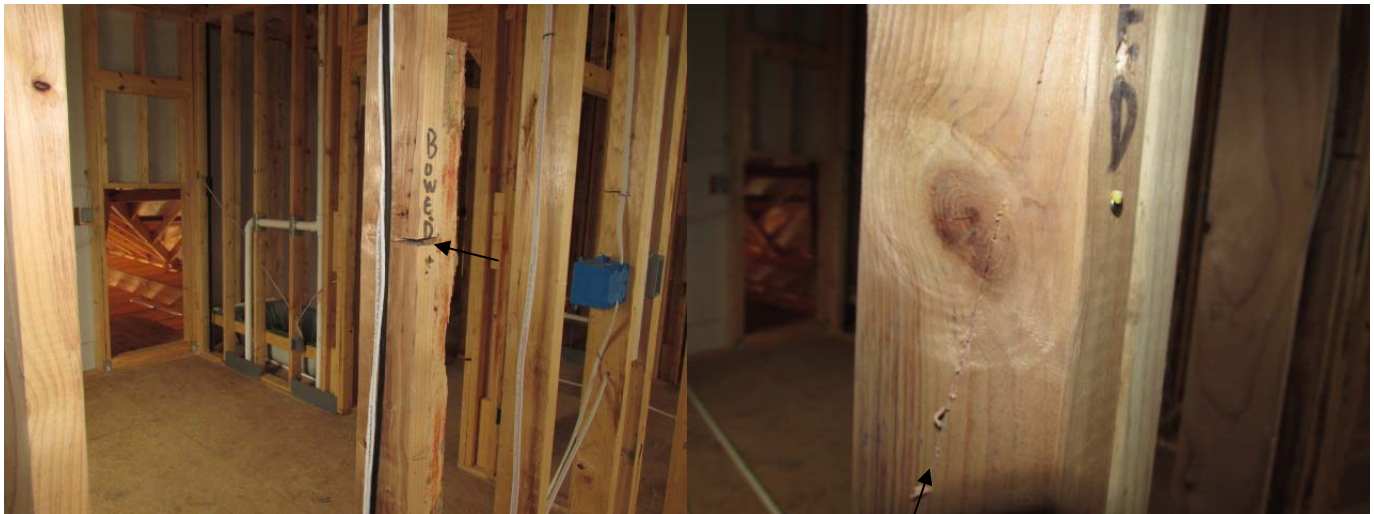
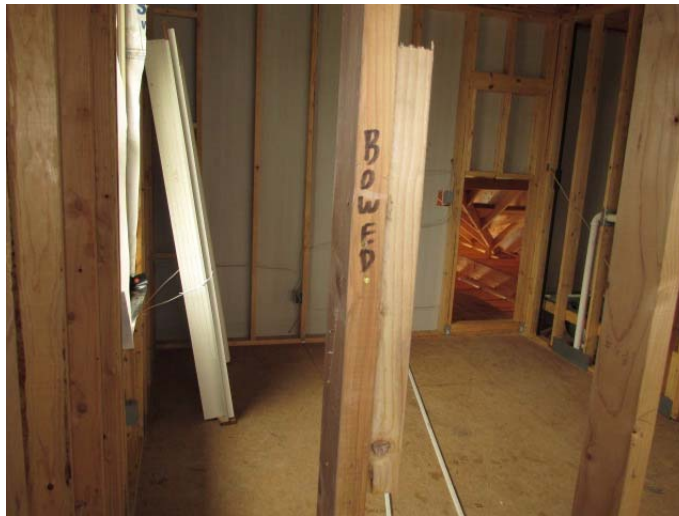
R – Approximately 30 % of the studs have warped and been cut then a short scab nailed to the side of the but stud – these studs are load bearing members and should be replace – scabs are not load bearing and fastening is subject to withdrawal\*\*\*.

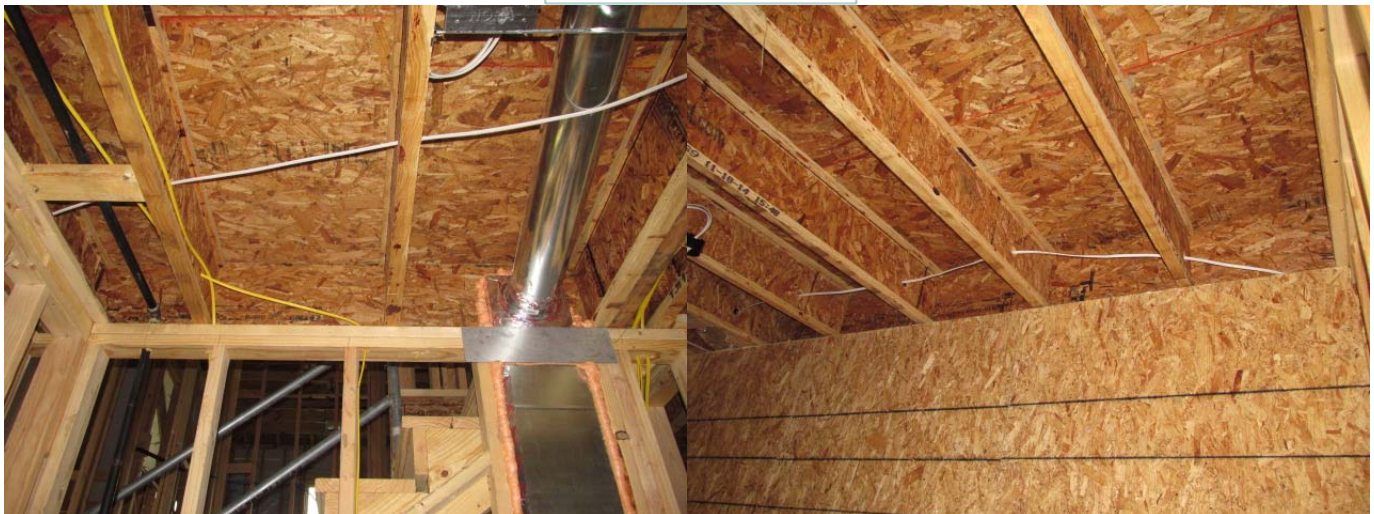
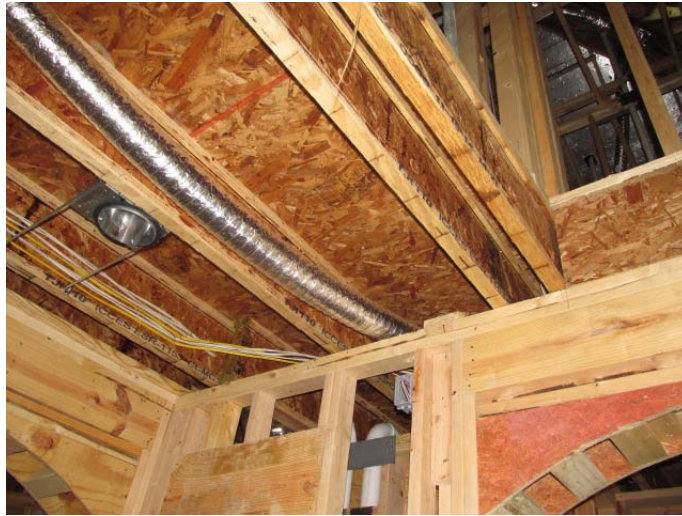
R – Some trusses are missing blocking and some are not installed properly;

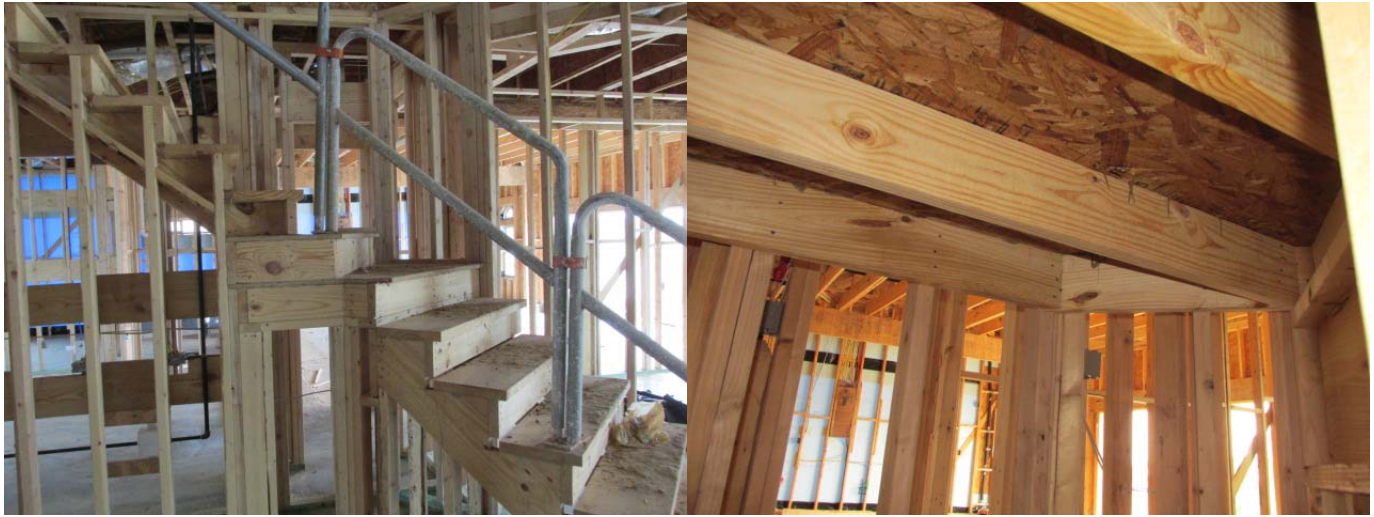
R – stairway landing steps should have a continuous load path\*\*\*via studs below the framing as the installed nailing is subject to withdrawal.

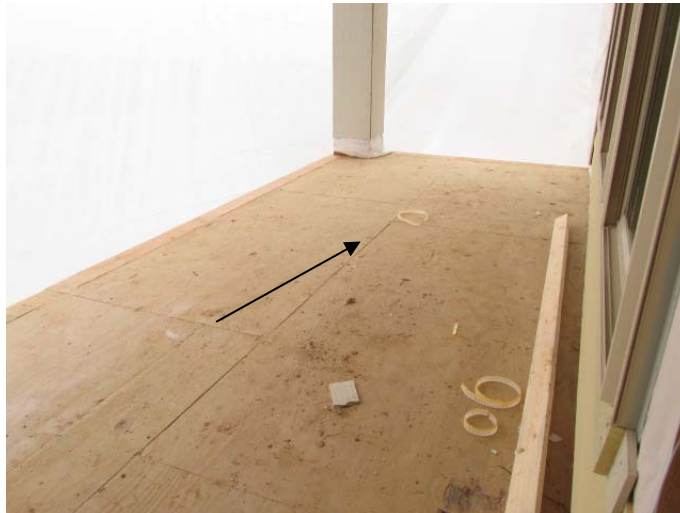
No water proofing was installed on the balcony at this time.

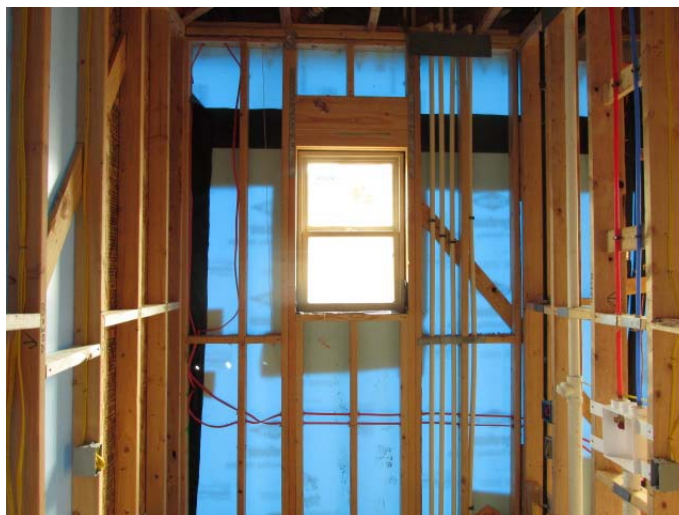
R – The laundry window is hung off level.

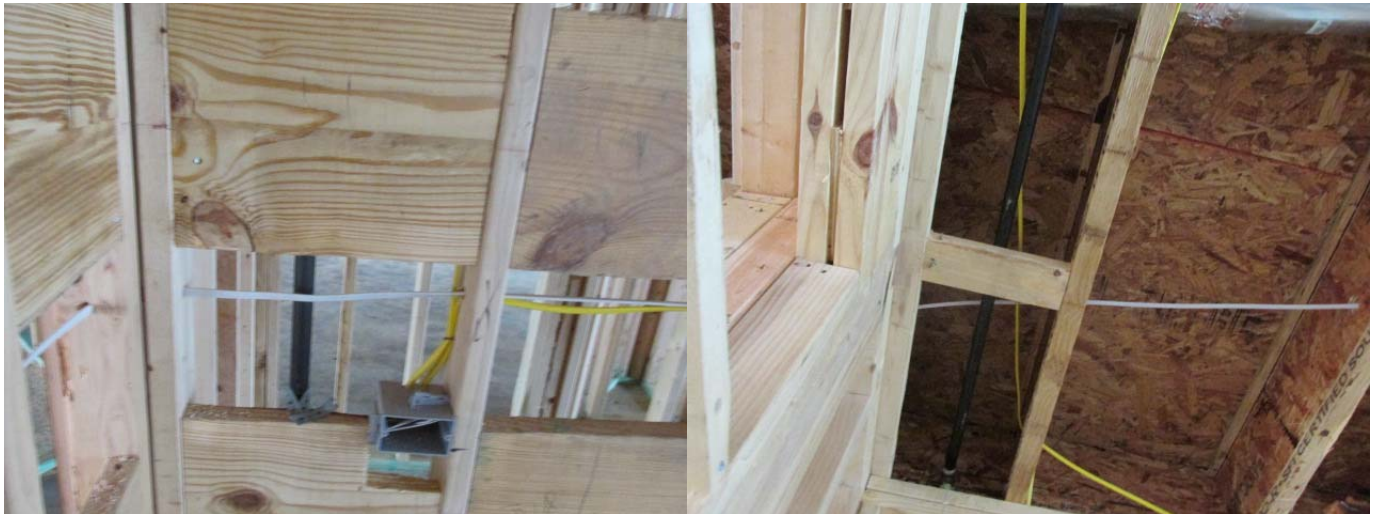
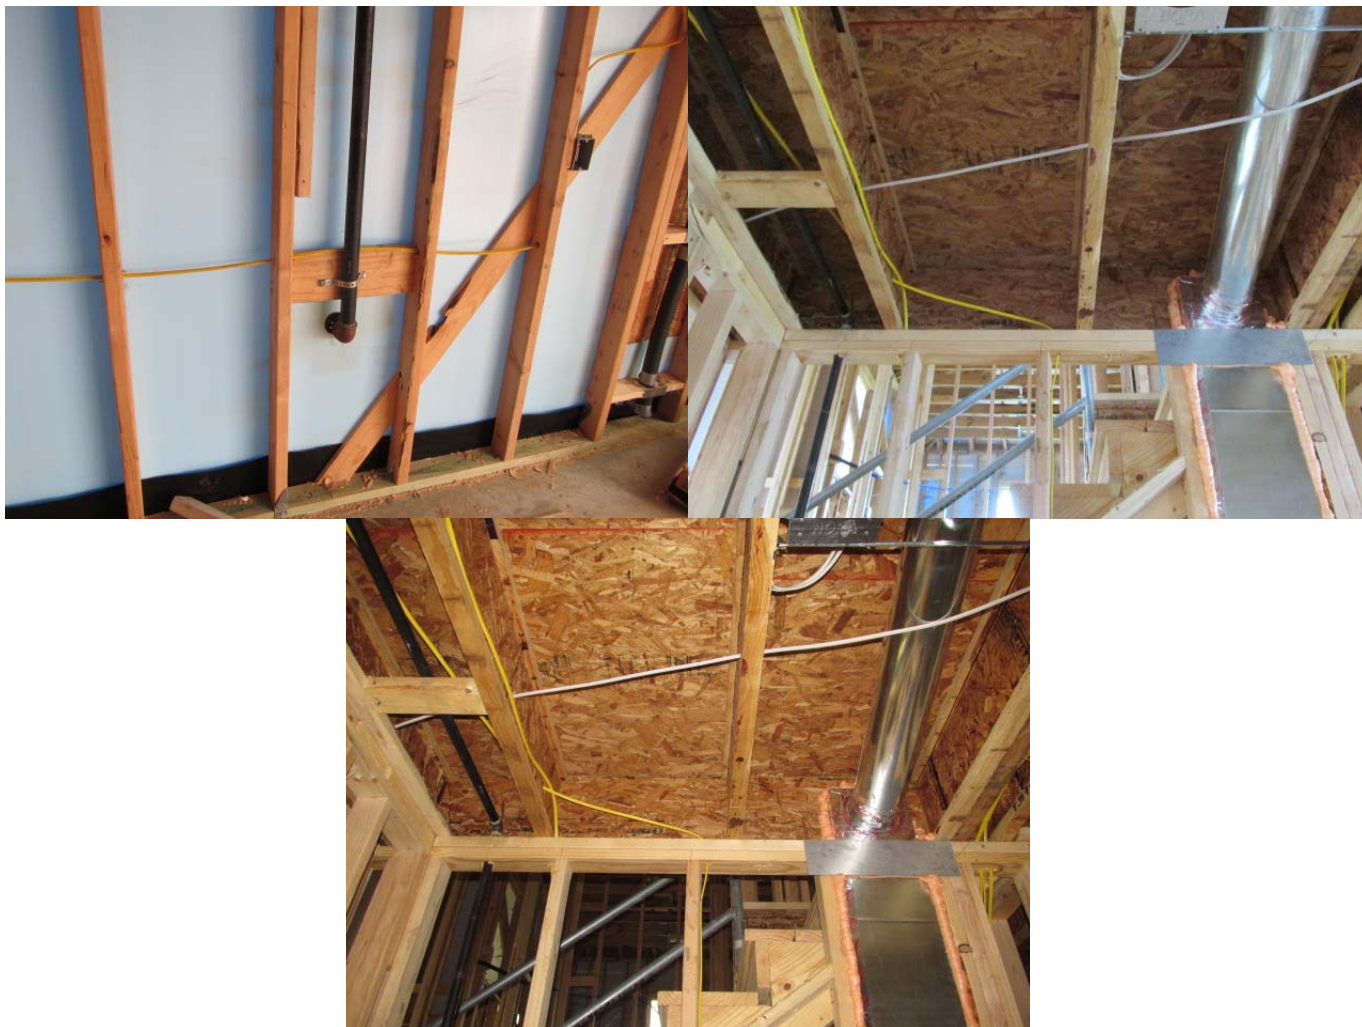
R – Wiring should not be allowed to touch water lines, gas lines or any other metal surfaces since the wearing of the sheathing will expose the bare wiring to the metal, electrifying that entire system. This is a shock hazard – kitchen wall and ceiling, garage.

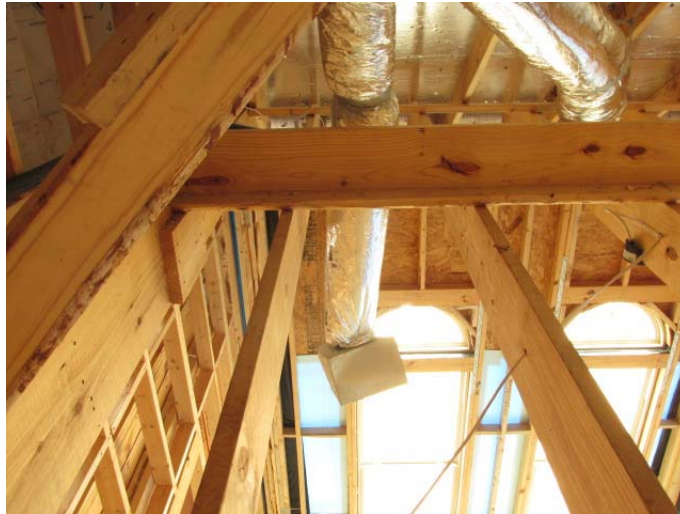
R – One formal living room duct box is hanging from the ducting.

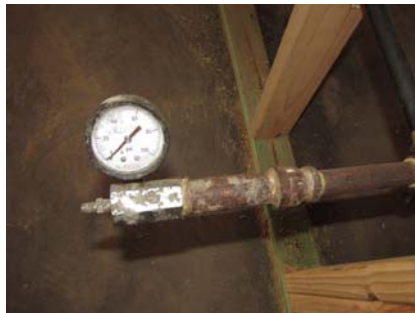
R – The gas lines were under pressure test today, the gauge showed zero pressure indicating a potential leak point.

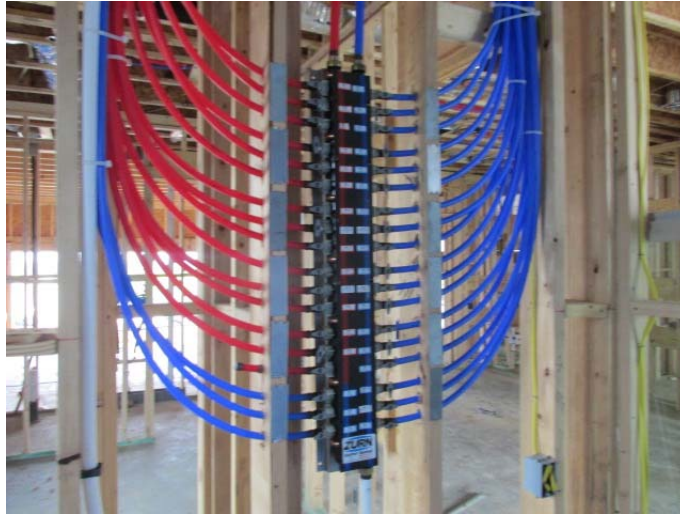
The supply system used in this home is PEX piping with a Manabloc manifold, the ASTM numbers were not accessible. This piping is not new but is relatively new to the Houston area residential market. Its acceptance, by the International Code Council (now adopted for the entire State of Texas) is also not known. Additional information is available at <http://rehau-na.com/index.html> under PEX systems. This website indicates acceptability for potable water use and testing per ASTM standards but there are no indications of acceptance by code or inspection agencies. It indicates that the connections should be ***“Standard barbed fittings and hose clamps are recommended for most applications. User is responsible for testing tubing and fittings in user’s application to confirm acceptable function.”***
