## PROPERTY INSPECTION REPORT

\_\_\_\_\_, **Cypress Texas in the community of Bridgeland**  
(Address or Other Identification of Inspected Property)

**Michael Cothran, C.I.O., TREI 2995**  
(Name and License Number of Inspector)

**03/19/2015**

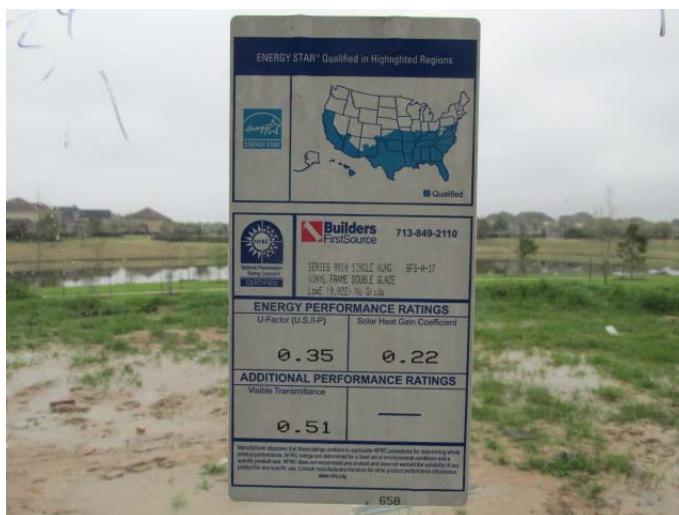
R – The laundry window is hung off level.
